# Service & repair hints of NOKIA 3210

Service & Analysis Center

The purpose of this document is to provide some further service information for NOKIA 3210 phones.

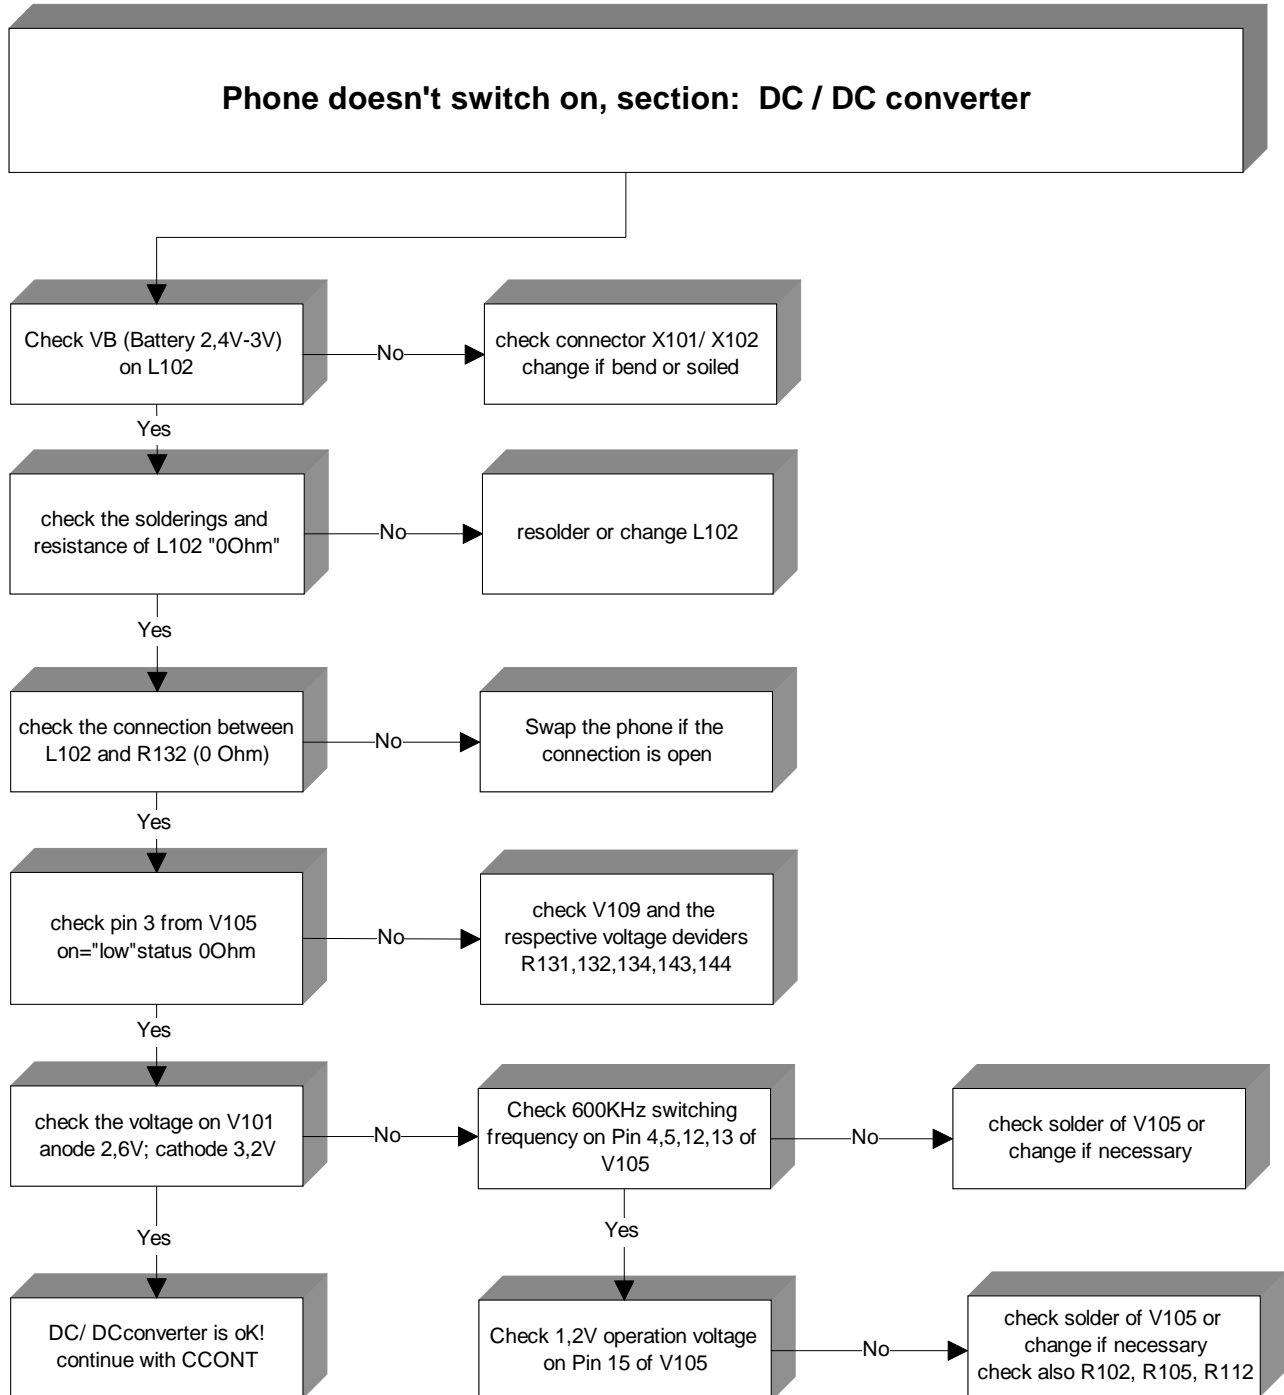
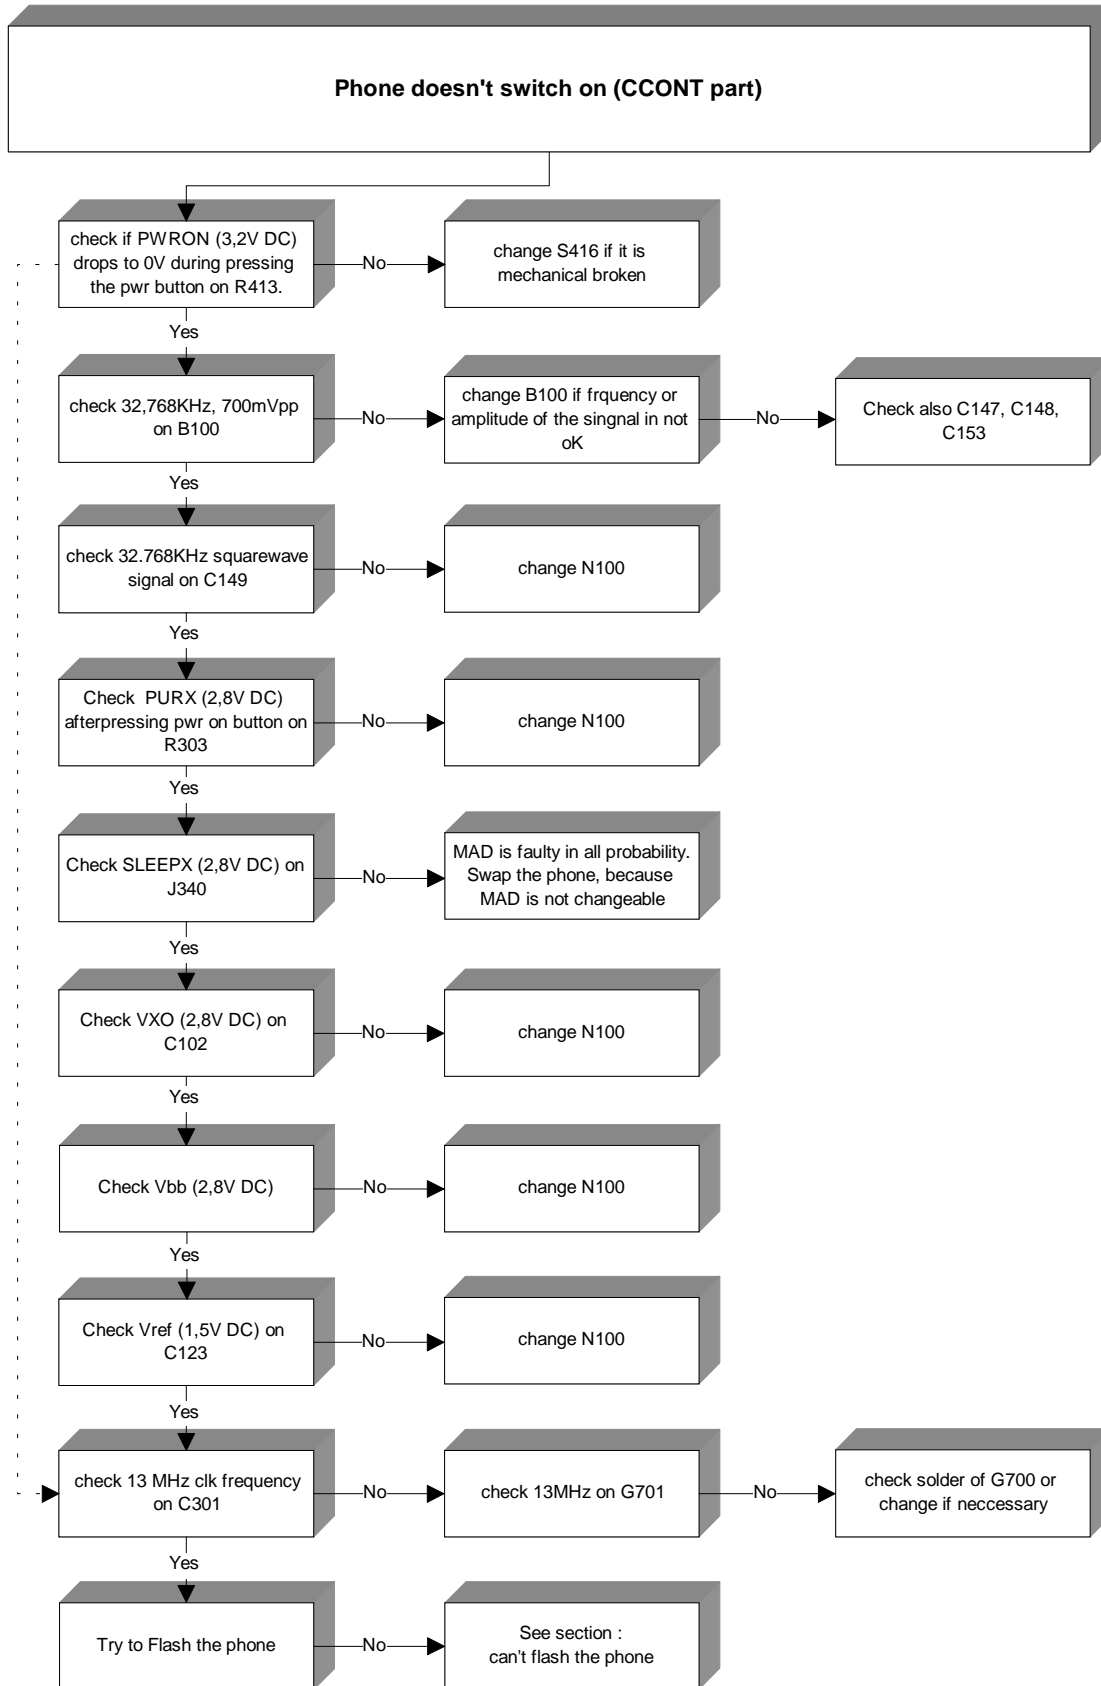
Doesn't Switch on

Battery connectors X101/ X102 / bend out dirty

Power on/off switch S416 faulty/ mechanical broken

L102 poor soldering

N100 CCONT faulty

B100 faulty 32,768KHz

G701 faulty 13 MHz

VB to R132 board faulty

D200 MAD faulty

V105 DC/DC converter faulty

- Check if VBATT and Gnd are connected

- Check if 3,2V on R413 drops of 0V during pressing the Power on button

- Check the soldering of L102
- Check the resistance in "off mode=0Ω"
- Resolder L102 or change it

- Check if 3,2V on R413 drops of 0V during pressing the Power on button
- Check if there is a 32.768 kHz square wave on C149
- Check if PURX on R303 goes up to 2.8 V DC
- Check if VXO on C102 goes up to 2.8 V DC
- Check if VBB on C117 goes to 2,8V DC
- Check if Vref on C123 goes to 1,5V DC

- Check 32.768 KHz ; 700mVpp clock signal on B100
- Check also C147, C148, C153

- Check VCC 2,8V DC on G701
- Check 13 MHz output frequency; 1,2 Vpp on the output pin

- Check the battery voltage 2,6V on L102
- Check the same voltage on R132
- Check if the connection from R132 to L102 are 0Ω
- Don't forget to put the additional label on the PCB, it save the layer (see Service Bulletin 11)

- Check if there is a 32,768 KHz square wave on C149
- Check the 13MHz main clock oscillator on C301 800mVpp
- Check VBB 2,8 V DC on C117
- Check PURX 2,8 V DC on R303 (comes from CCONT)
- Check SLEEPX 2,8 V DC On measurement point J 340
- MAD are probable faulty
- MAD are not interchangeable swap the handset

- Check the voltage difference on the diode V101 Anode: 2,6V DC, cathode: 3,2V DC
- Check the 600KHz switching frequency on pin 4, 5, 12, 13 from V105
- Check the 1,2V operation voltage on pin 15 from V105
- Check if pin 3 from V105 have low status ≈0V, if not check V109 and the respective voltage dividers R131, R132, R134, R143, R144
- Change the V105

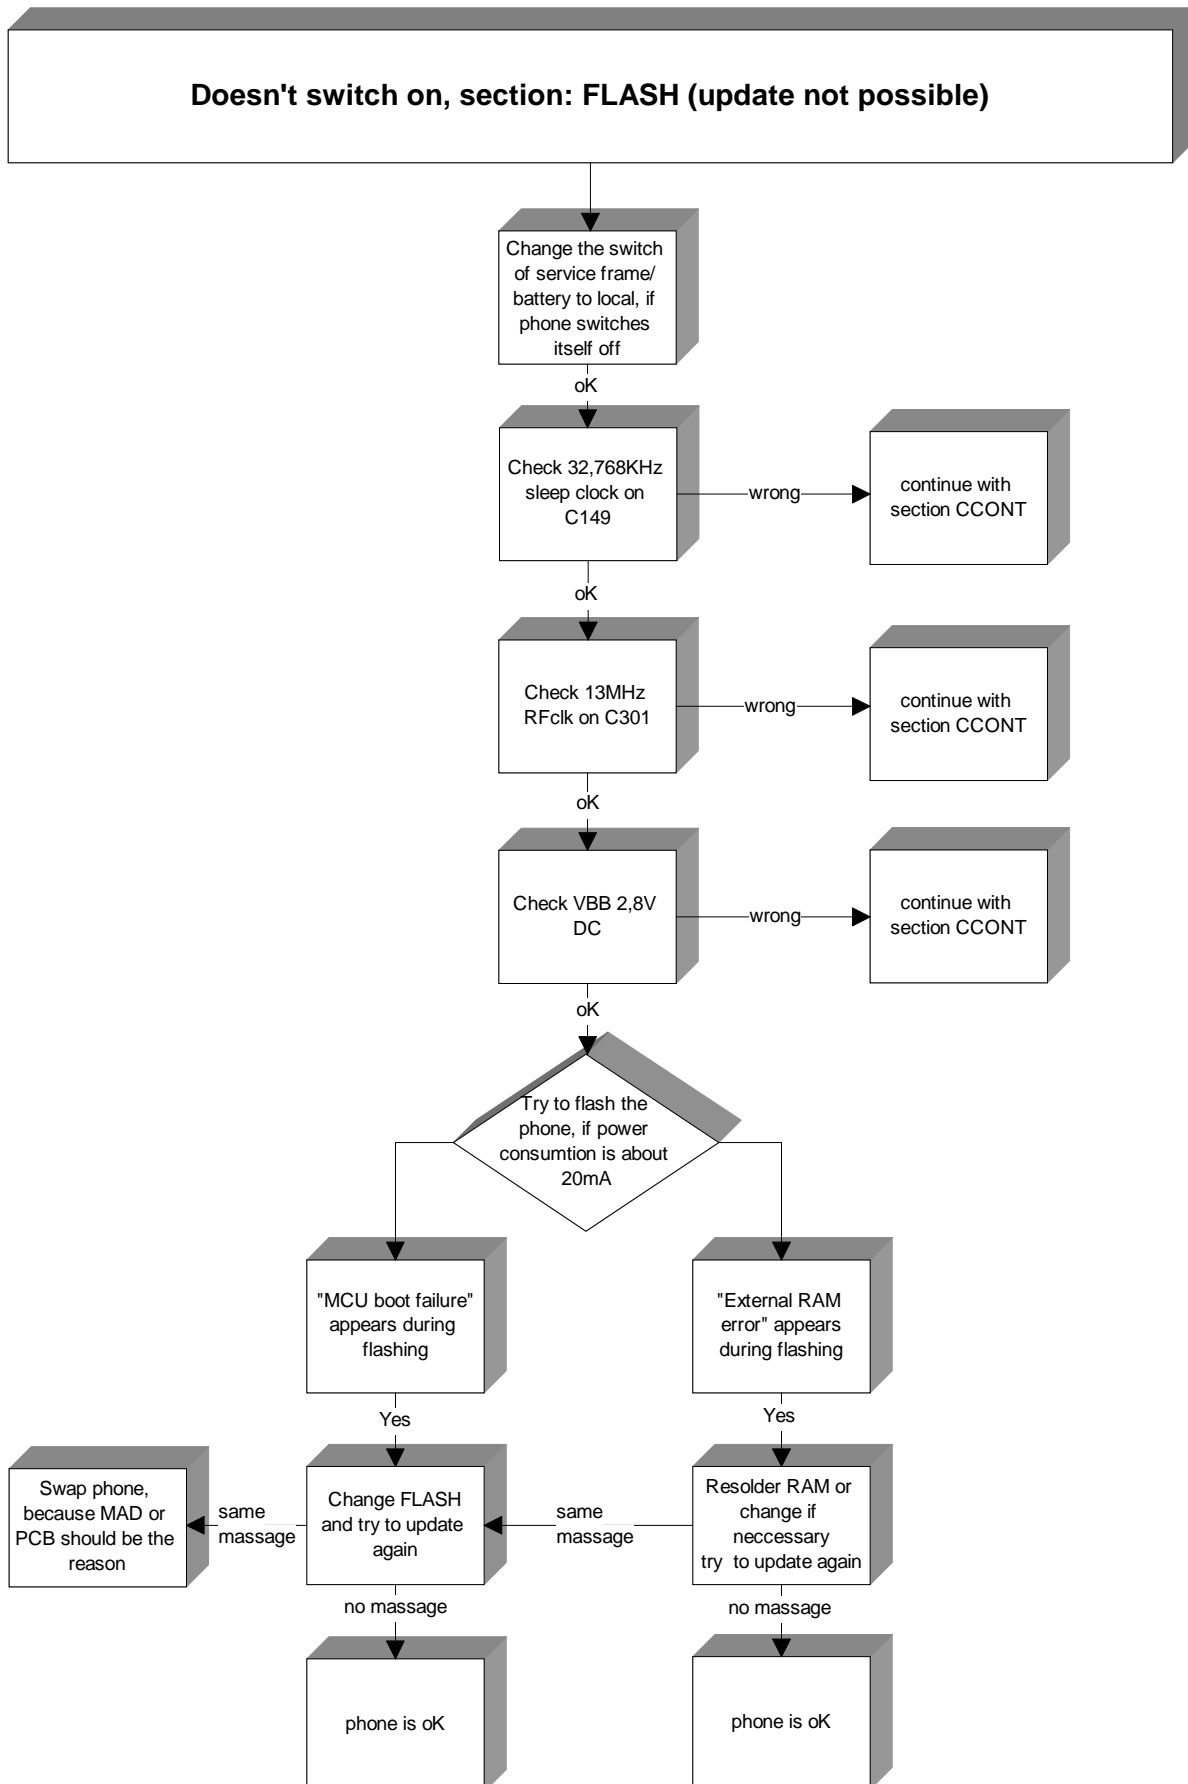
No flash update possible/ Doesn't switch on

## D301 Flash faulty

## D302 RAM faulty/ poor soldering

- If the handset switches it self off, change the switch of the service frame to local mode
- Check the 32,768KHz Sleep clock signal on C149
- Check the 13MHz main clock oscillator on C301 800mVpp
- Check the VBB voltage on C117
- If power consumption is approximately 20mA try to flash the phone
- If you get a error message during the flashing process, change the flash and try it again

- Check if the handset current consumption is approx. 20mA
- Check the 32,768KHz Sleep clock signal on C149
- Check the 13MHz main clock oscillator on C301 800mVpp
- Check the VBB voltage on C117
- Resolder RAM
- Try to flash the handset
- Change the RAM if you get a error message during the flash procedure "[external RAM error](#)"

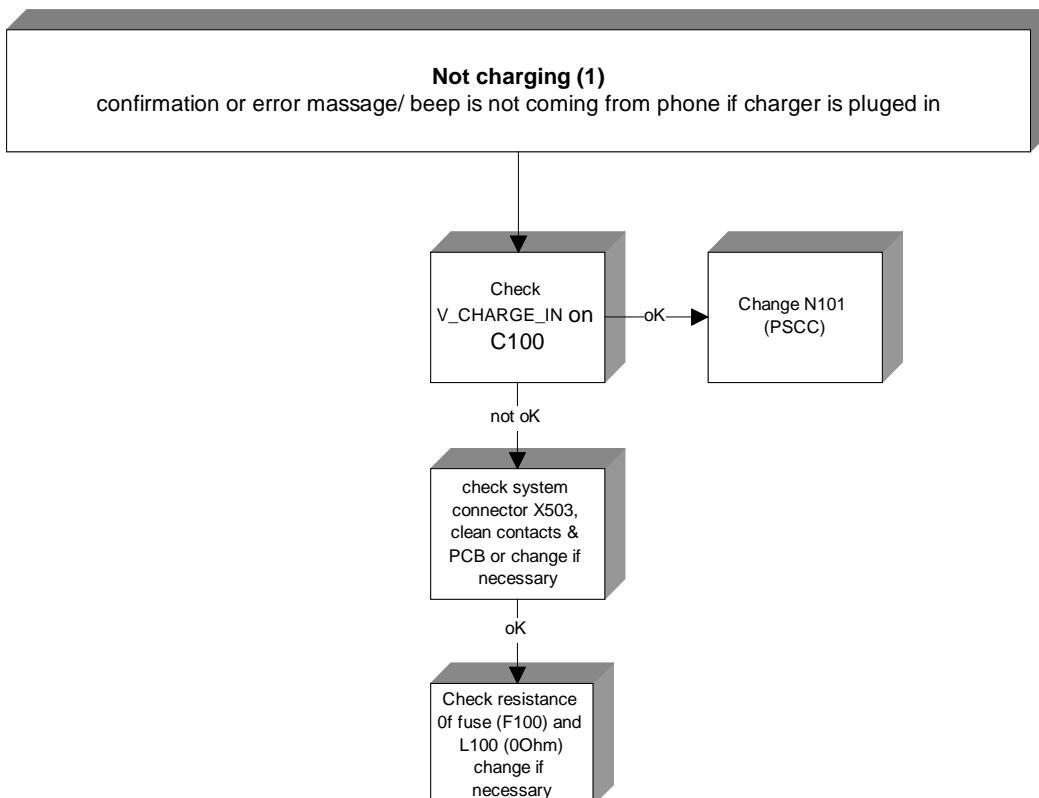
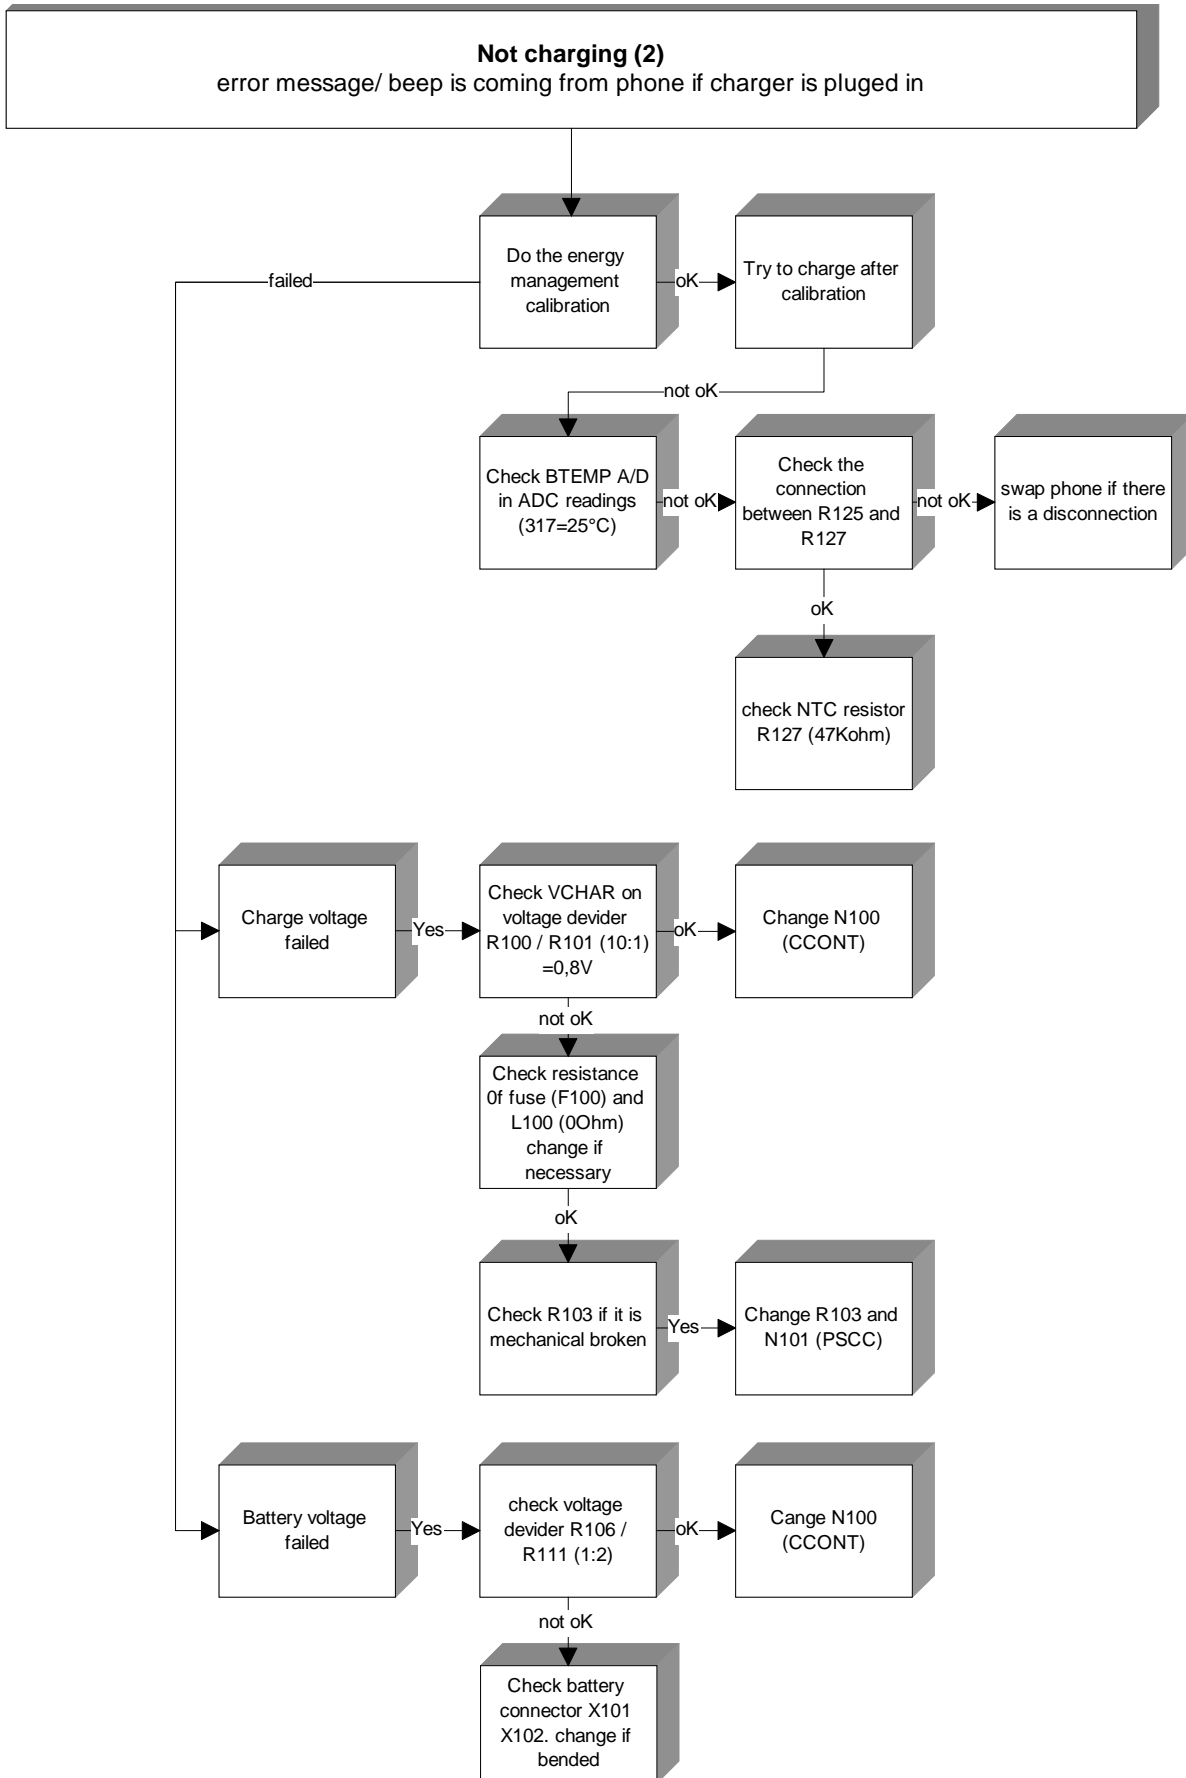
## Not charging

X503 System connector faulty

F100 faulty

N100 CCONT faulty/ poor soldering

R103 broken and N101 PSCC electrical faulty

R125 and R127 connection faulty

- Check the mechanical appearance of the connector
- Clean the contacts on the board or change the connector if necessary

- Check resistance of F100 (0Ω)
- Check the resistance V\_charge line to ground (OK=10KΩ)

- Check if any A/D values are out of limit but the corresponding DC voltages is OK ([wintesla/ local mode/ Testing/ ADC Readings...](#))
- If DC voltages are wrong, check corresponding voltage dividers (R100, R101)
- Check PWMOUT on R117 or R142 (1 Hz standard / 32 Hz fast)

- Check if the handset doesn't charge with the ACP-9 fast charger
- Check the mechanical appearance of the varistor R103
- If it's broken change it, in this case change also N101 PSCC

- Check if any A/D value is out of limit special [BTEMP \(317≅25°\)](#)
- Check the connection between R125 and R127
- Check the NTC resistor R127 47KΩ

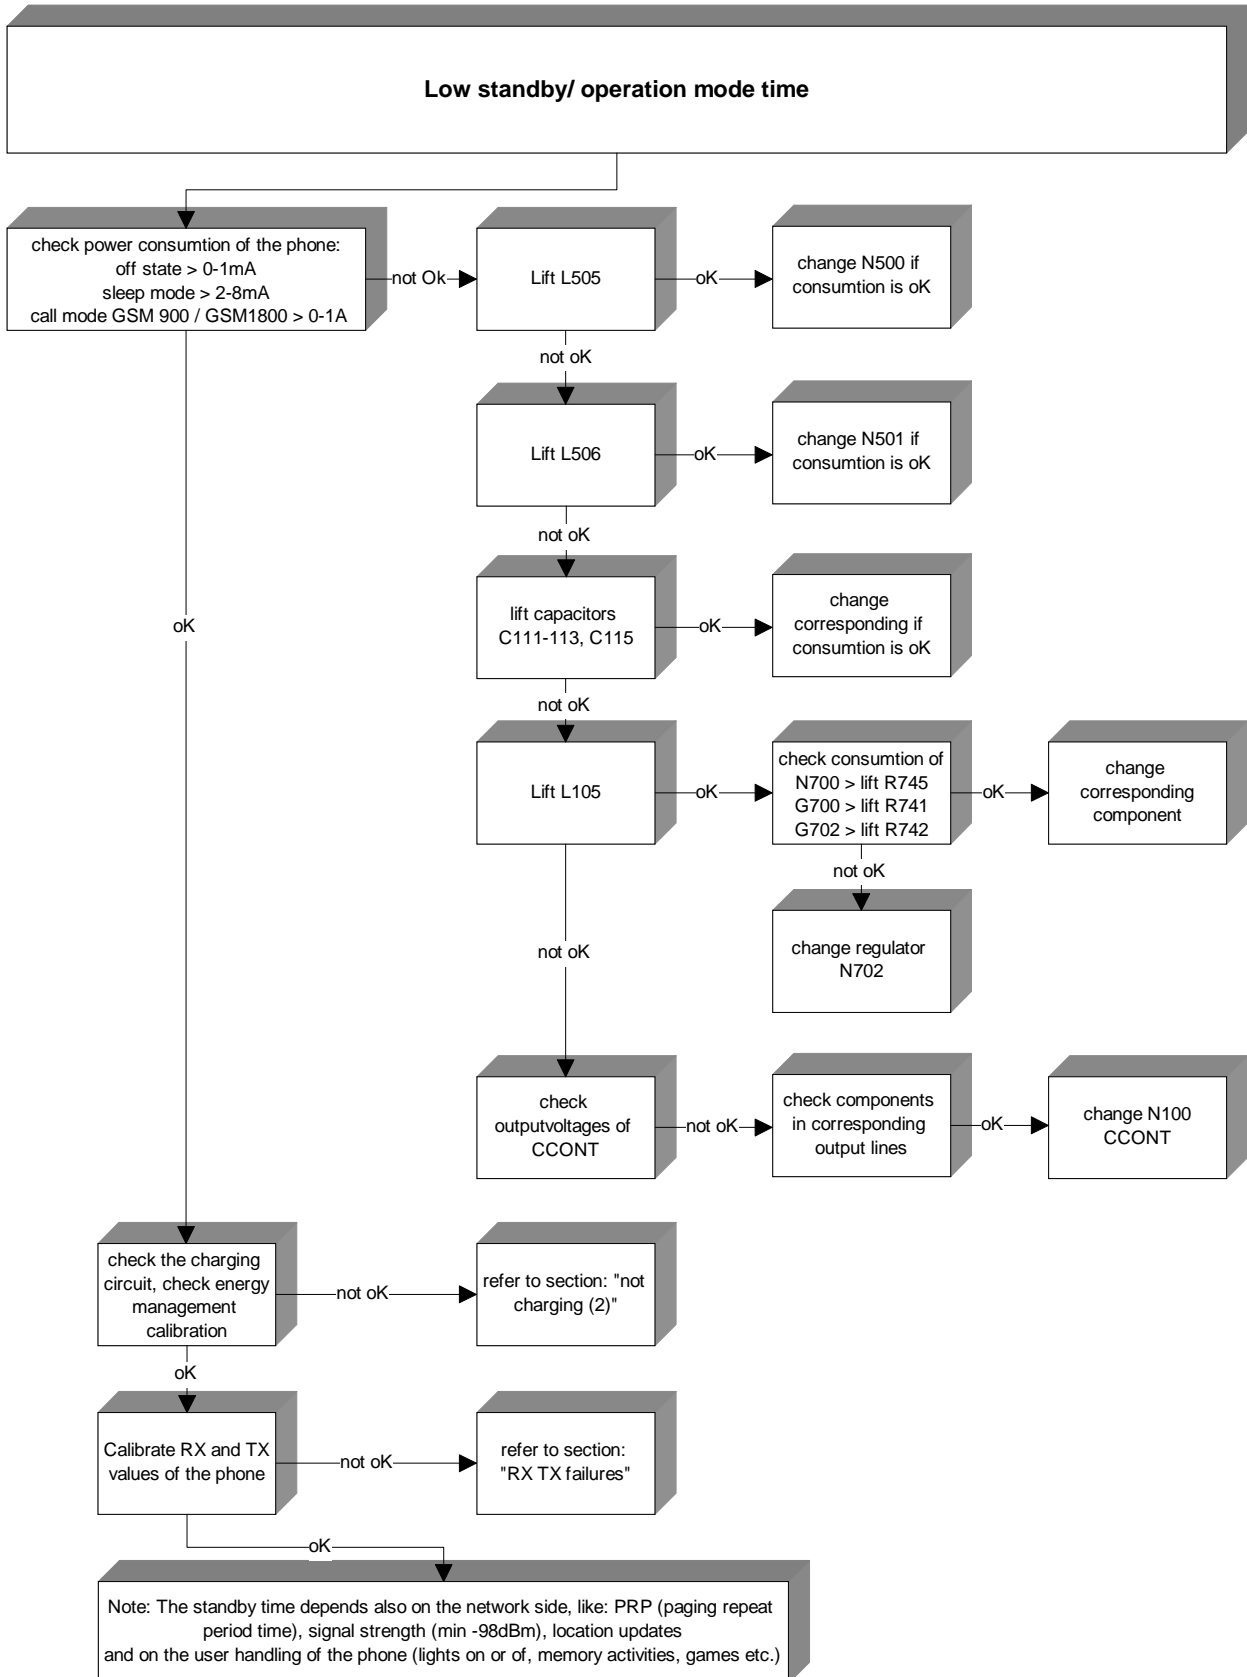
Low stand by time/ operation time

## C111, C115, C113 faulty

- Check the current consumption in different operation modes (refer to the table below)
- Check if the high current consumption comes from the VB, Vout or output voltages of CCONT
- Disconnect coil by coil L105 (→N702) L505, L506 (→PA's) and check consumption again
- Check and disolder C111, C115 and C113
- calibrate Battery value if charging stops to early or battery is to hot after charging (see also chapter "Not charging")

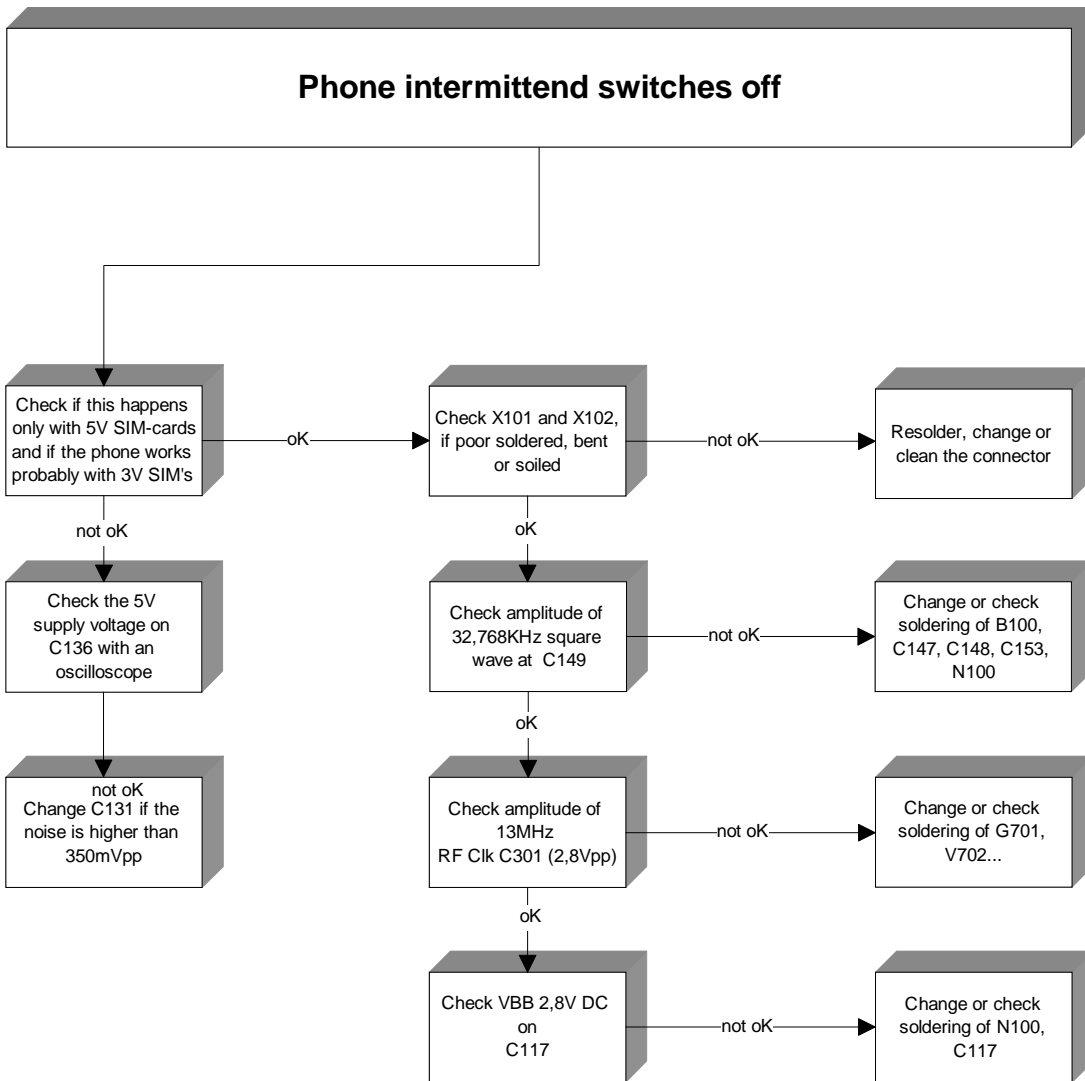
Phone switch it self off

C136 10µF/10V

- Check, if the handset doesn't switch off with 3V SIM-Cards
- Check that the 5V VSIM voltage on the capacitor C136 is approximately 4,8V-5,2V with maximal 350mVpp noise overlap (view the diagram below)

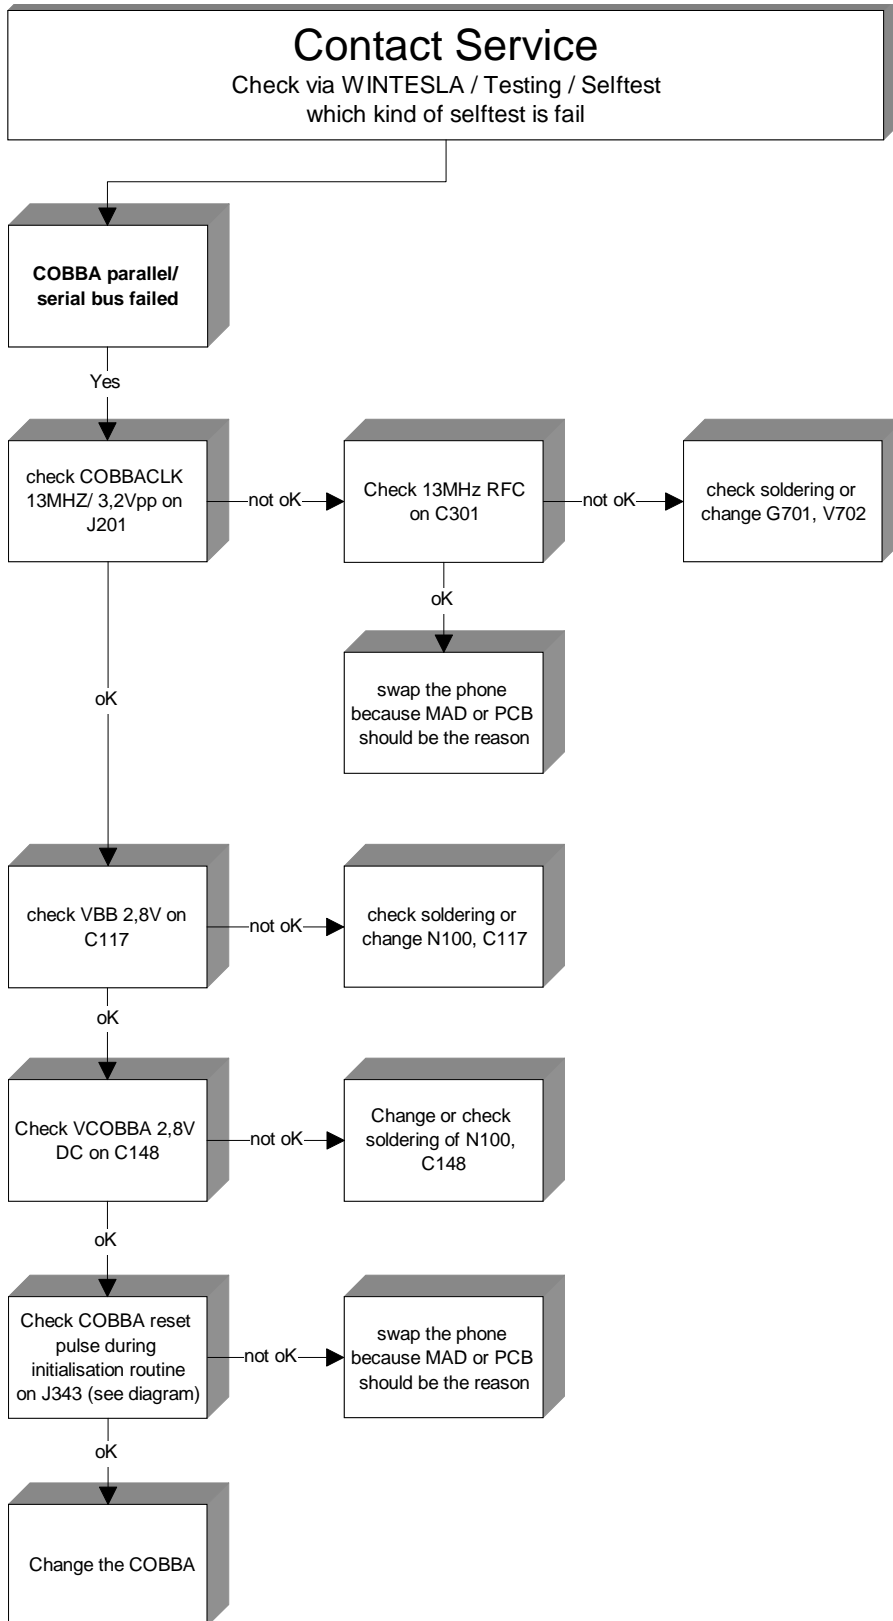
Contact service COBBA parallel /serial bus fail

N200 COBBA faulty /solder balls broken

- Check VBB 2,8V DC on C117 near to CCONT
- Check VCOBBA 2,8V DC C148 near to COBBA
- Check COBBACKL 13MHz 3,2Vpp on J 201 (see the diagram below)
- Check COBBA reset impulse during the initialisation routine on J343 (see the diagram below)
- Change COBBA and write the IMEI and SIM-LOC DATA back to the phone
- If the error persist, the MAD or the Board should be the reason
- SWAP the handset because MAD is not changeable

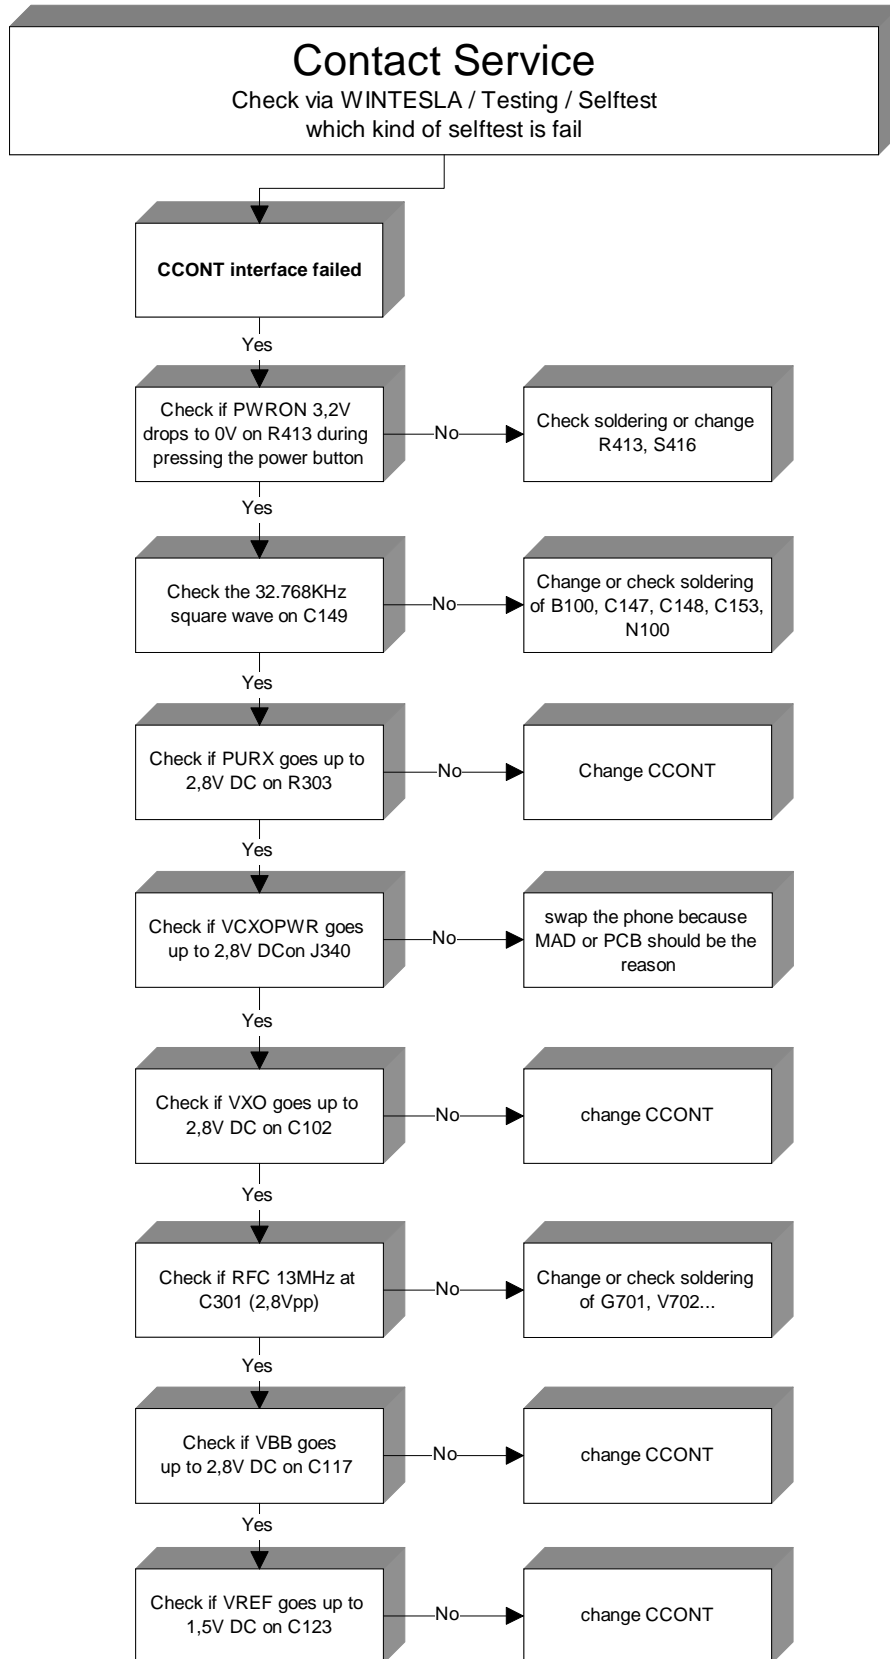
Contact Service-CCONT interface fail

N100 CCONT Faulty

- Check if 3,2V on R413 drops to 0V during pressing the Power on button
- Check if there is a 32.768 kHz square wave on C149
- Check if PURX on R303 goes up to 2.8 V DC
- Check if VXO on C102 goes up to 2.8 V DC
- Check if VBB on C117 goes to 2,8V DC
- Check if Vref on C123 goes to 1,5V DC
- Change the CCONT

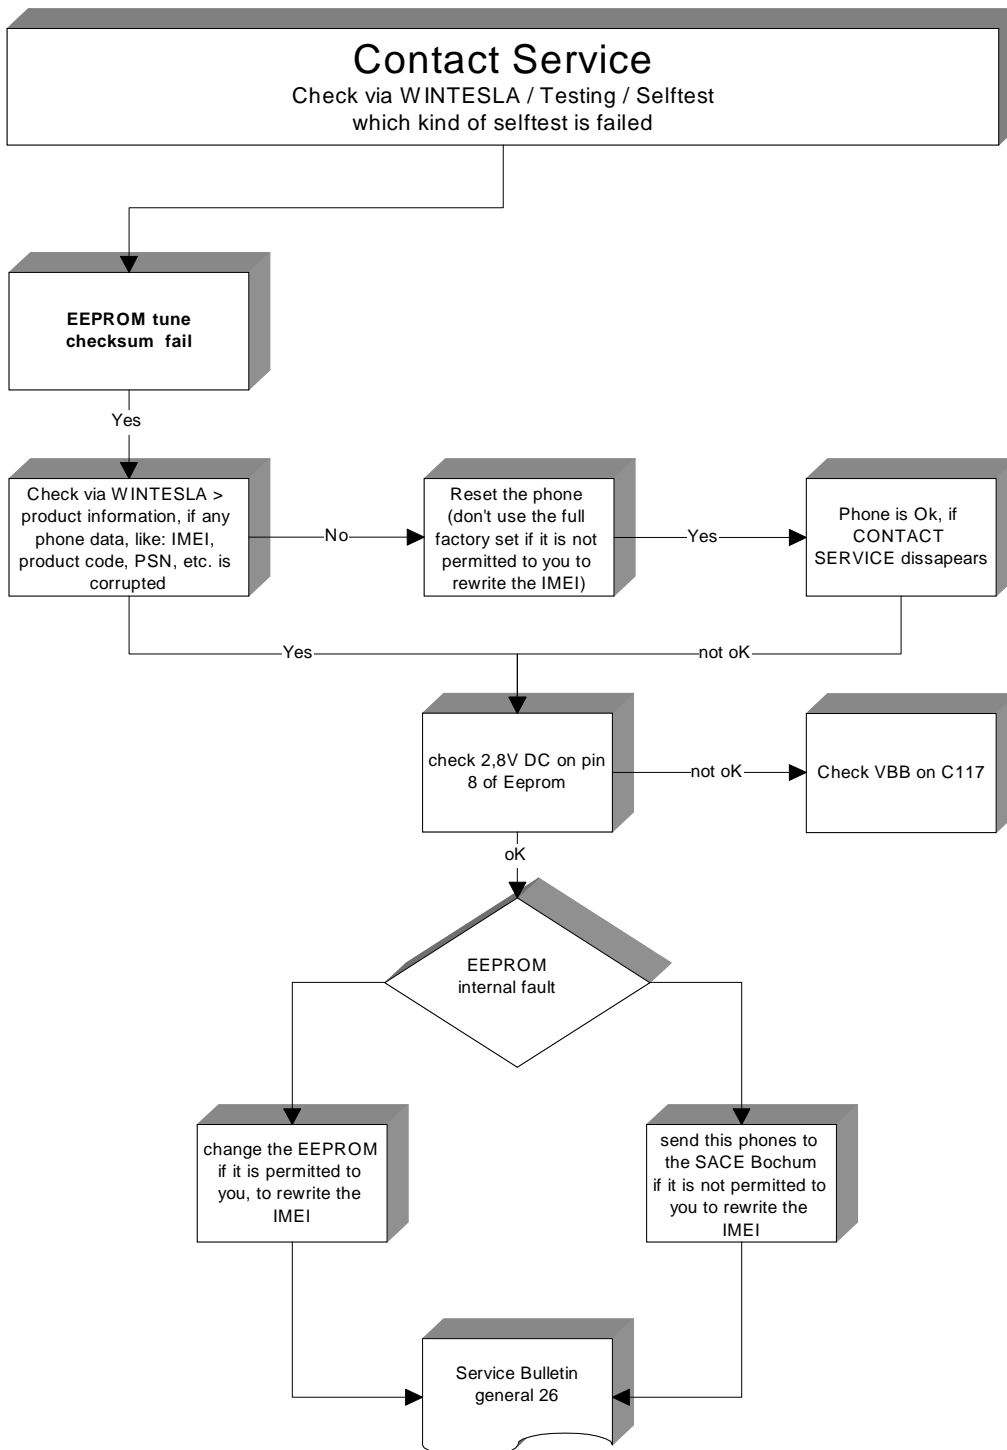
Contact service – Eeprom checksum fail

## D303 Eeprom faulty

- Check with wintesla if IMEI or product data are corrupted
- Check 2,8V DC on pin 8 of Eeprom
- Don't use the "Full factory set" with wintesla, otherwise the Original IMEI will be change to "65656565..."
- Change the Eeprom if it's permitted to you and write all ID data (IMEI, product code...) back
- If you aren't allowed to change the Eeprom and the IMEI is missing, write a note with a little comment, and send it together with the phone to the SACE

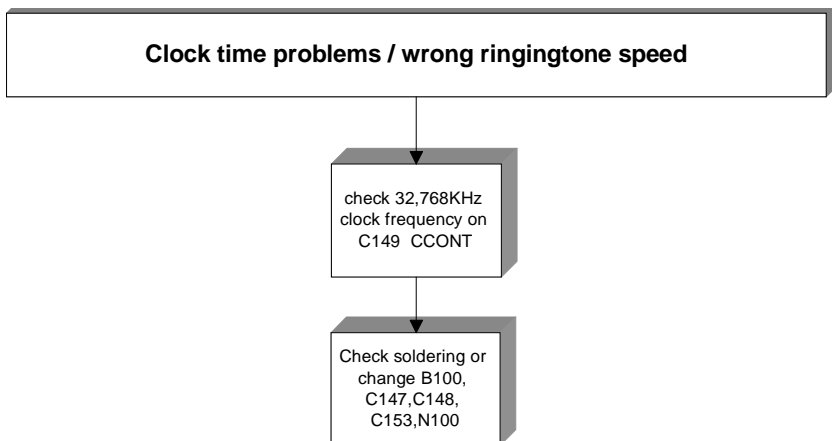
## Clock time or user settings problems

### Clock time / Ringing tone is to fast or to slowly

#### 32,786KHz Sleep oscillator B100

- Check that the sleepclk 32.768KHz square wave frequency on pin C149 isn't higher or lower
- Check the crystal B100, C147, C148, C153, N100
- View also the Service Bulletin 017 (capacitors C148, C153 change the value)

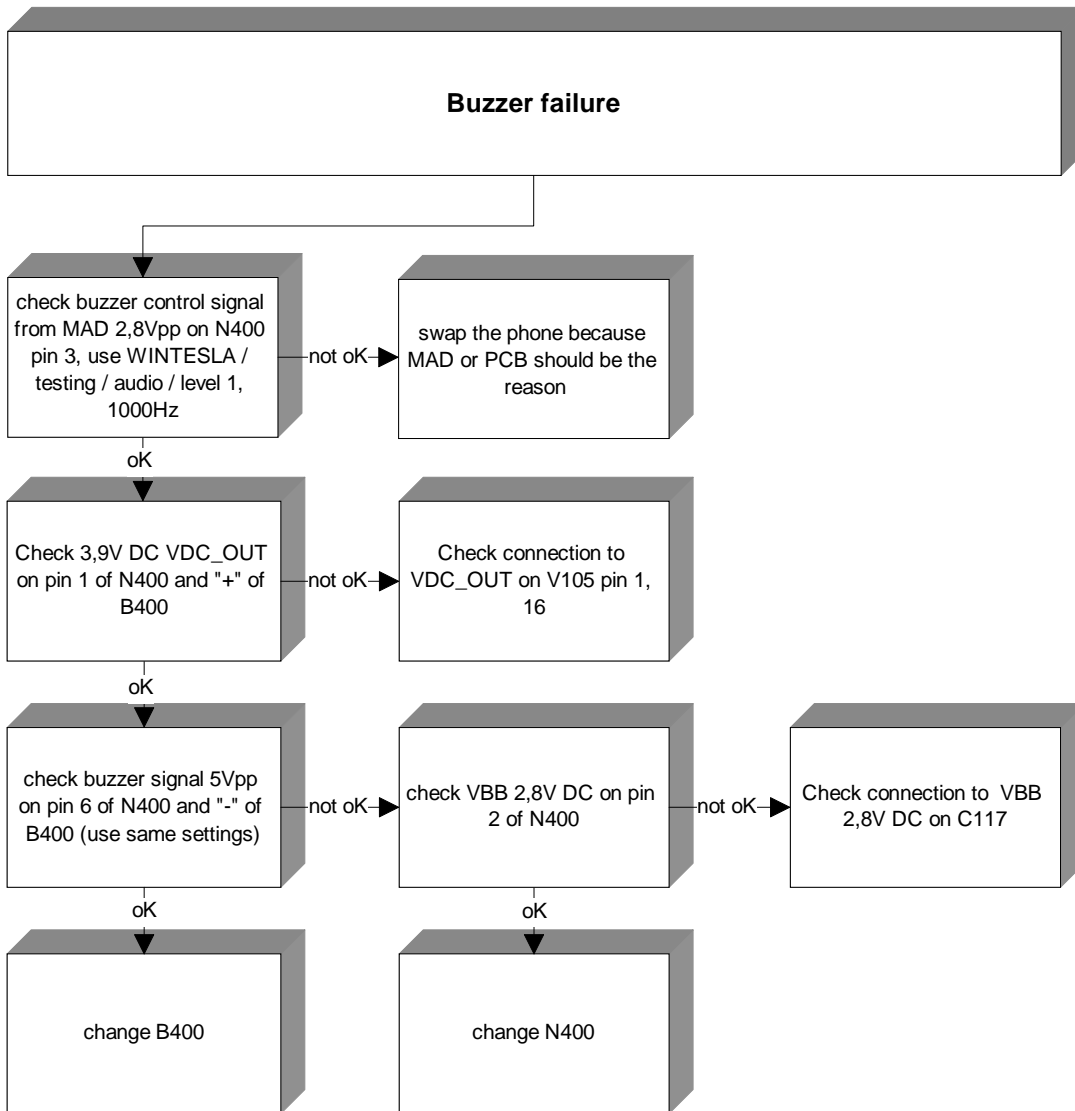
Buzzer failures

B400 / board connections broken

- Check the buzzer control signal from the MAD on pin 3 of N400 2,8Vpp 1KHz (use [WINTESLA / testing / audio Level 1, 1000Hz](#))
- Check VDC\_OUT 3,9V DC pin 1 N400 and "+" of buzzer
- Check VBB 2,8V DC on pin 2 N400
- Check the buzzer Signal on "-" of buzzer ≈ 5Vpp 1KHz
- Check the board connection pin 6 of N400 to "-" of buzzer
- Change the buzzer

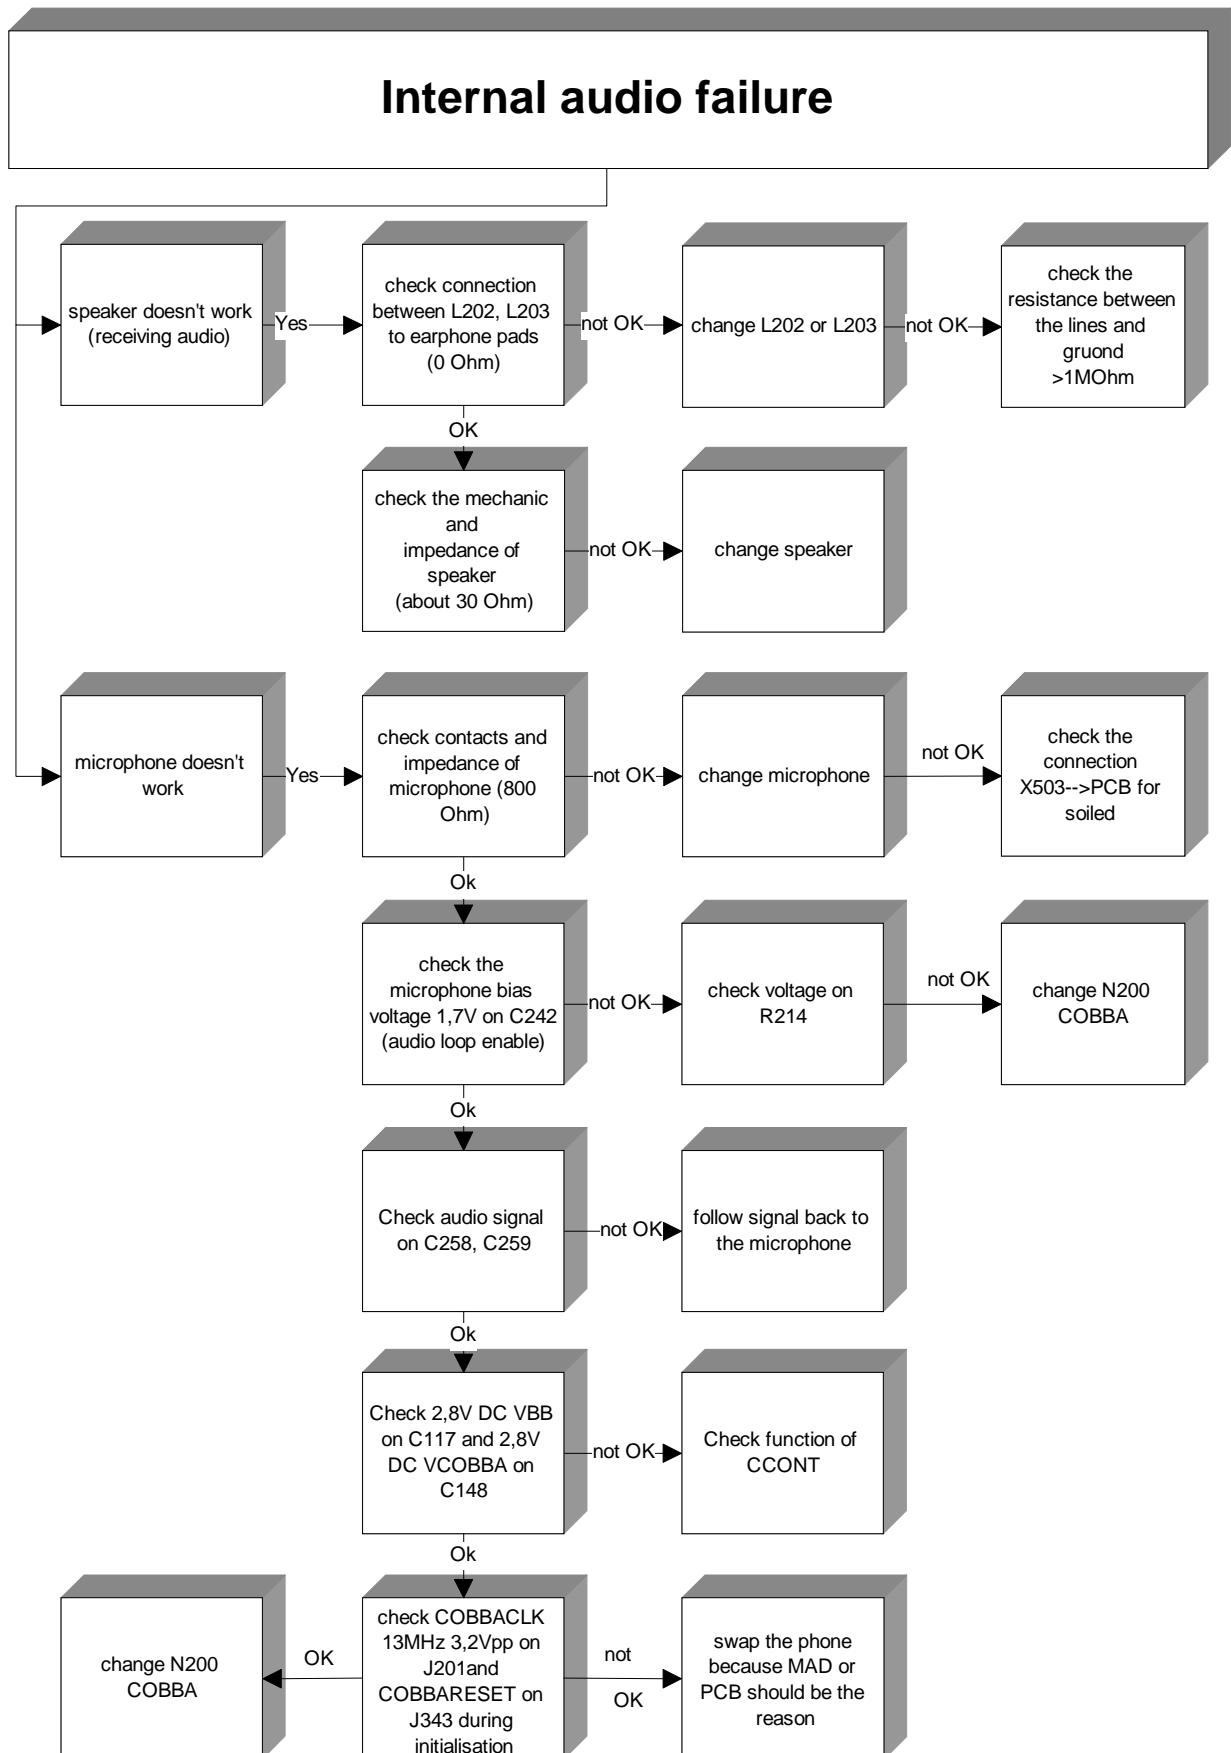
Internal audio failures

## L202, L203 faulty

No / quiet / distorted receiving audio signal

No / quiet / distorted transmitting audio signal

- Check resistance from L202, L203 to the earphone pads normal  $0\Omega$
- Check the resistance also from L202,L203 to ground and between both lines (normal high resistance  $>1M\Omega$ )

- Check the mechanic of speaker, contacts, membrane, soiling
- Check resistance of speaker (about  $30\Omega$ )

- Check contacts of microphone  
Check resistance of microphone (about  $800\Omega$ )
- Check the microphone voltage 1,7V DC on C242 ([wintesla/ Testing/ Audio/ internal/ Loop on](#))
- Check the audio signal on C258 and C259

- Check microphone spring contacts
- Check spring contacts to the board (change connector if bent)
- Clean the contact pads on the board
