# Service & repair hints of NOKIA 3210

Service & Analysis Center

The purpose of this document is to provide some further service information for NOKIA 3210 phones.

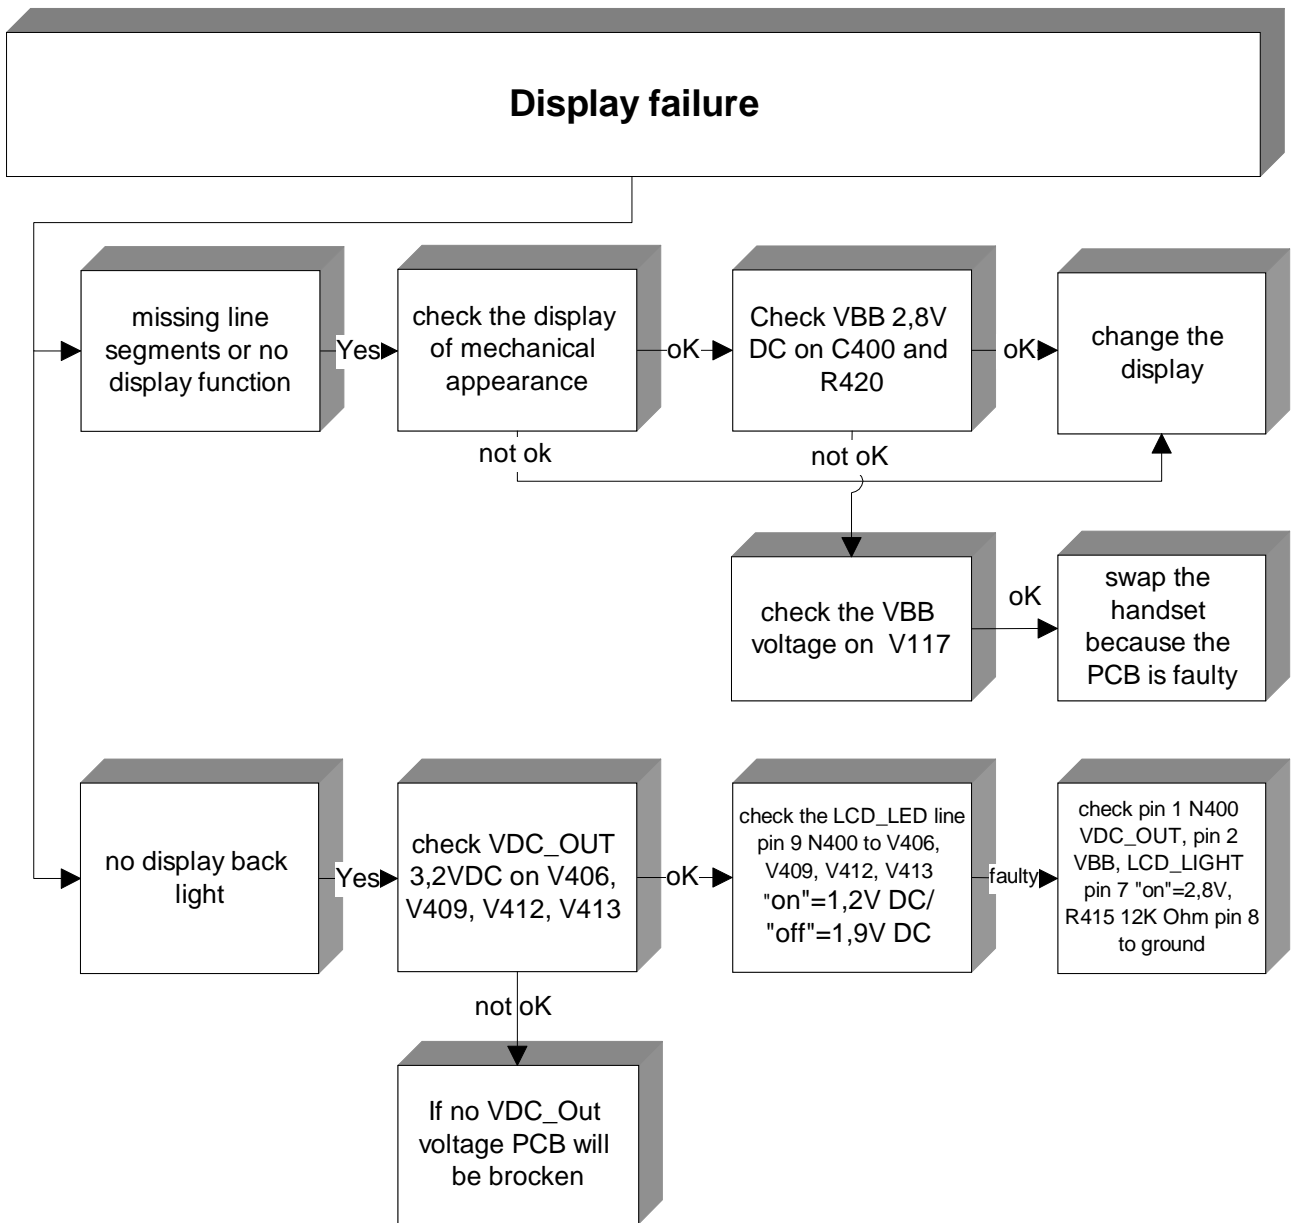
Display failures

Black lines on the display or no display function

- Check if the display have some mechanical breaks around the corners
- Check VBB 2,8V DC on C400 and R420
- Change the Display

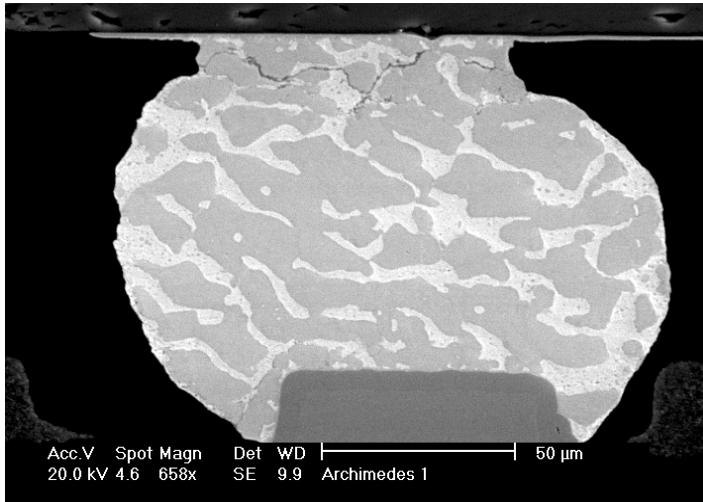
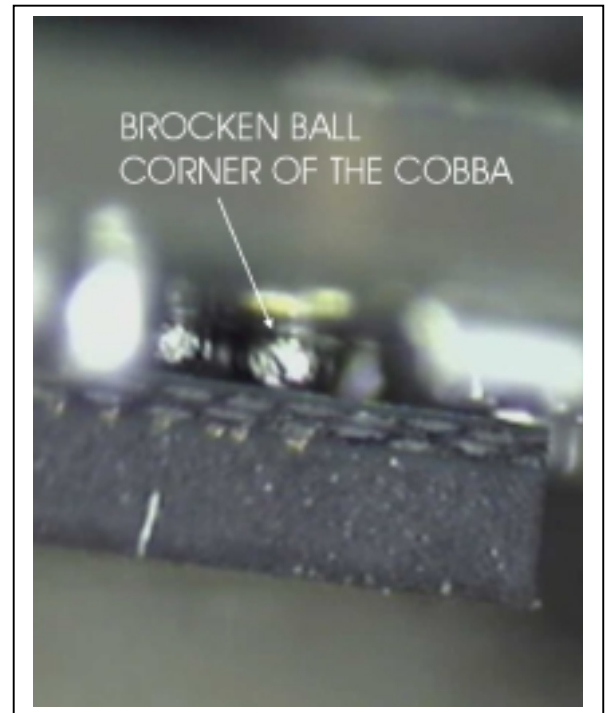
### COBBA N200 broken solder balls

The pictures indicate a typically case of broken solder ball under the  $\mu$ BGA. On the right you can see the little part of the COBBA IC view with a microscope. The PCB is on the top, and the COBBA are with the body to the bottom of the picture. The picture below shows a broken ball view through a X-ray machine

- Check VBB 2,8V DC on C117 near to CCONT
- Check VCOBBA 2,8V DC C148 near to COBBA
- Check COBBACKL 13MHz 3,2Vpp on J 201 (see the diagram in chapter "COBBA contact service" )
- Check the module in call modus with a simulator.
- Knock very careful with something no metallated around the COBBA
- Check if some errors appear on the tester (phase /frequency / RX-Quality/TX-Power level)
- Check the COBBA IC with a microscope, the first broken balls are normal on the corners from circuit.
- Change the circuit with a µBGA solder machine
