# Service & repair hints of NOKIA 3210

Service & Analysis Center

The purpose of this document is to provide some further service information for NOKIA 3210 phones.

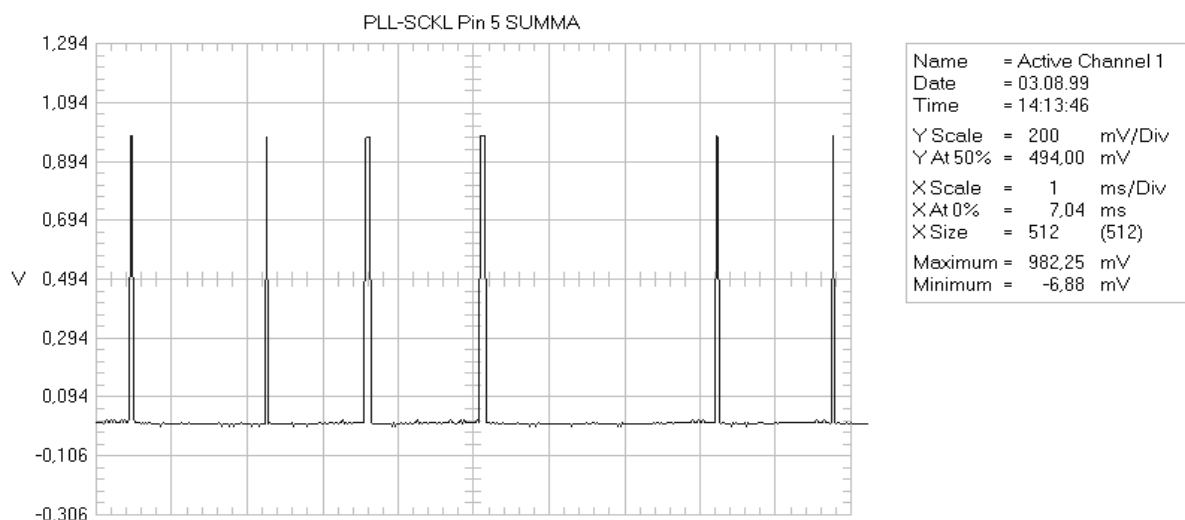
Figure 7: PLL-SCKL Signal

- check the 13MHz reference frequency pin 15 N700. (No frequency deviation higher  $\pm 50\text{Hz}$  is allowed!)
- check the power supply voltage VRX\_2 2,8V DC pin 35 N600
- check the incoming IF 71MHz pin 37,38 N700
- check the 13MHz IF on pin 30(out),25, 26(in) N700 . The attenuation between input and output are  $\approx 20\text{dBm}$
- check the control-lines for the PLL pin 5, 6, 7 from N700 (see the diagrams below)
- check the incoming VHF\_LO frequency 464MHz pin 8 N700 if the 13MHz IF are deviated or not exist measurable level approximate  $-20\text{dBm}$ !
- Check the synth. power supply 2,8V DC pin 9, 19 N700 and VCC G700, G702
- Check the VCP 5V DC pin 13, 22 N700
- Check the control voltage for the UHF and VHF oscillator (UHF pin 21 control voltage is channel dependent, pin12 2,2V DC on N700)
- Check the soldering of N700 or change it

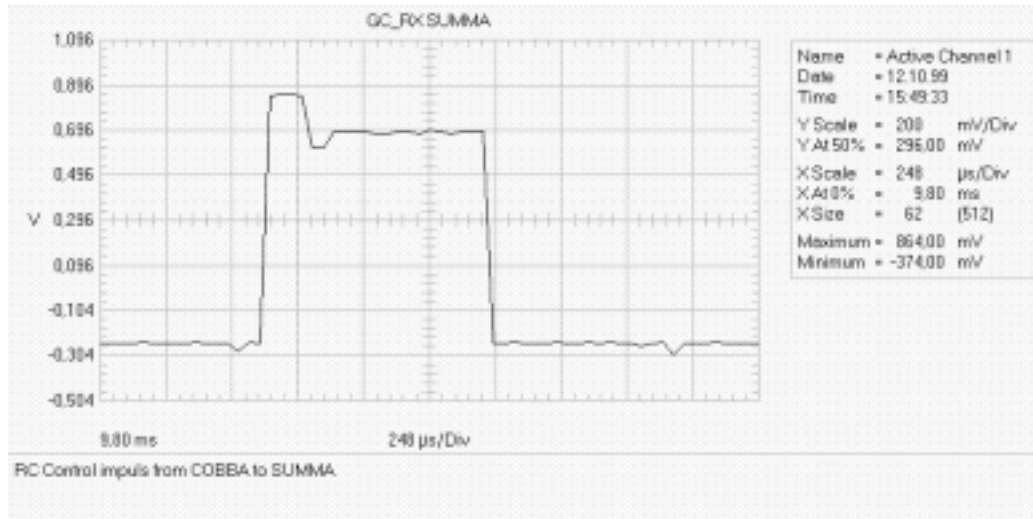
Figure 10:RX-Control Signal

No RX (no Rx calibration...RSSI reading fixed value)

COBBA / MAD faulty /broken solder balls

Note! Rewrite SIMLOCK and IMEI entries with use of the Nokia security SW (SSSW) and make a SW-update or send this phones to the SACE, if this procedure is not permitted to you

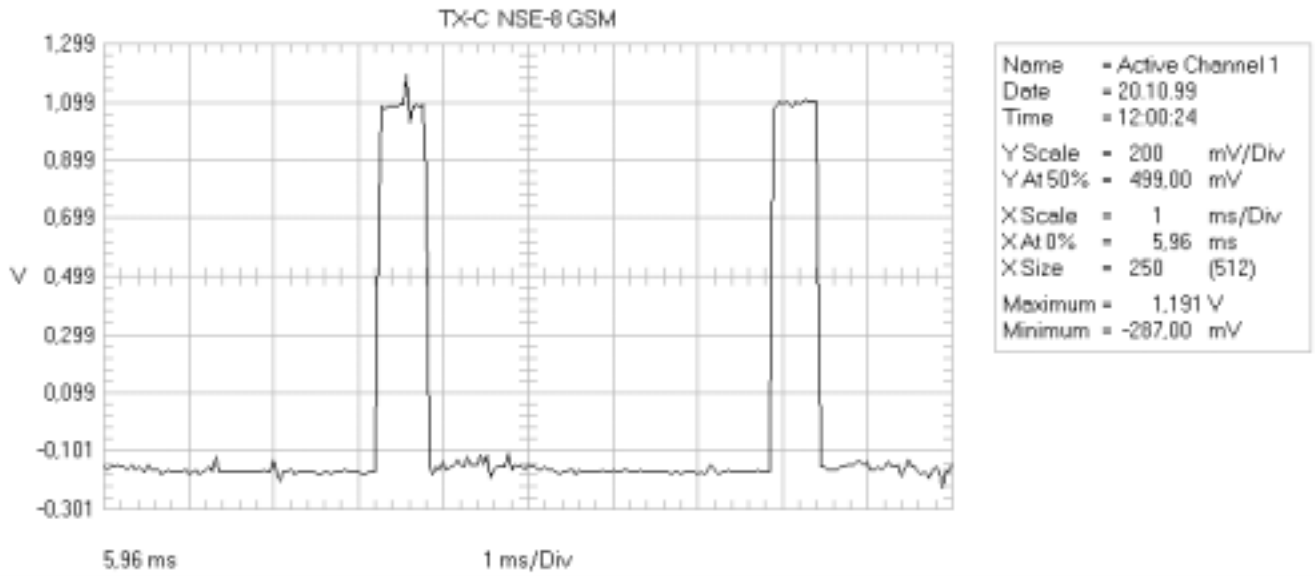
Figure 11:TX-Control Signal

- Check the power supply VDC\_OUT(3,2V→4,2V dependent to the power level) N500 /N501 pin 3
- Check the input power on pin N500/ N501 depend of the band (nominal 0dbm)
- Check the outgoing power on pin 4 N500/ N501
- Check the TX-Power control signal on pin 2 N500/ N501 , 0,7Vpp-1,7Vpp / 0,12..V - 0,2..V DC dependent of the power-level (see the diagram below)
- Change the PA if no power or to low power comes out and the power supply and control line are OK

TX-control impuls on pin 2 from N500/N501  
example on GSM 900 TX-level 6 approx. 32dBm
